**VILLAGE OF ALGONQUIN/KANE
COUNTY ISOLATED WETLAND
PERMIT & BMP PLAN SUBMITTAL**

The Trails of Woods Creek Subdivision Development
Algonquin, McHenry County, Illinois

**RE: Village of Algonquin Wetland Permit Submittal
Proposed Trails of Woods Creek Residential Subdivision Development
Algonquin, McHenry County, Illinois**

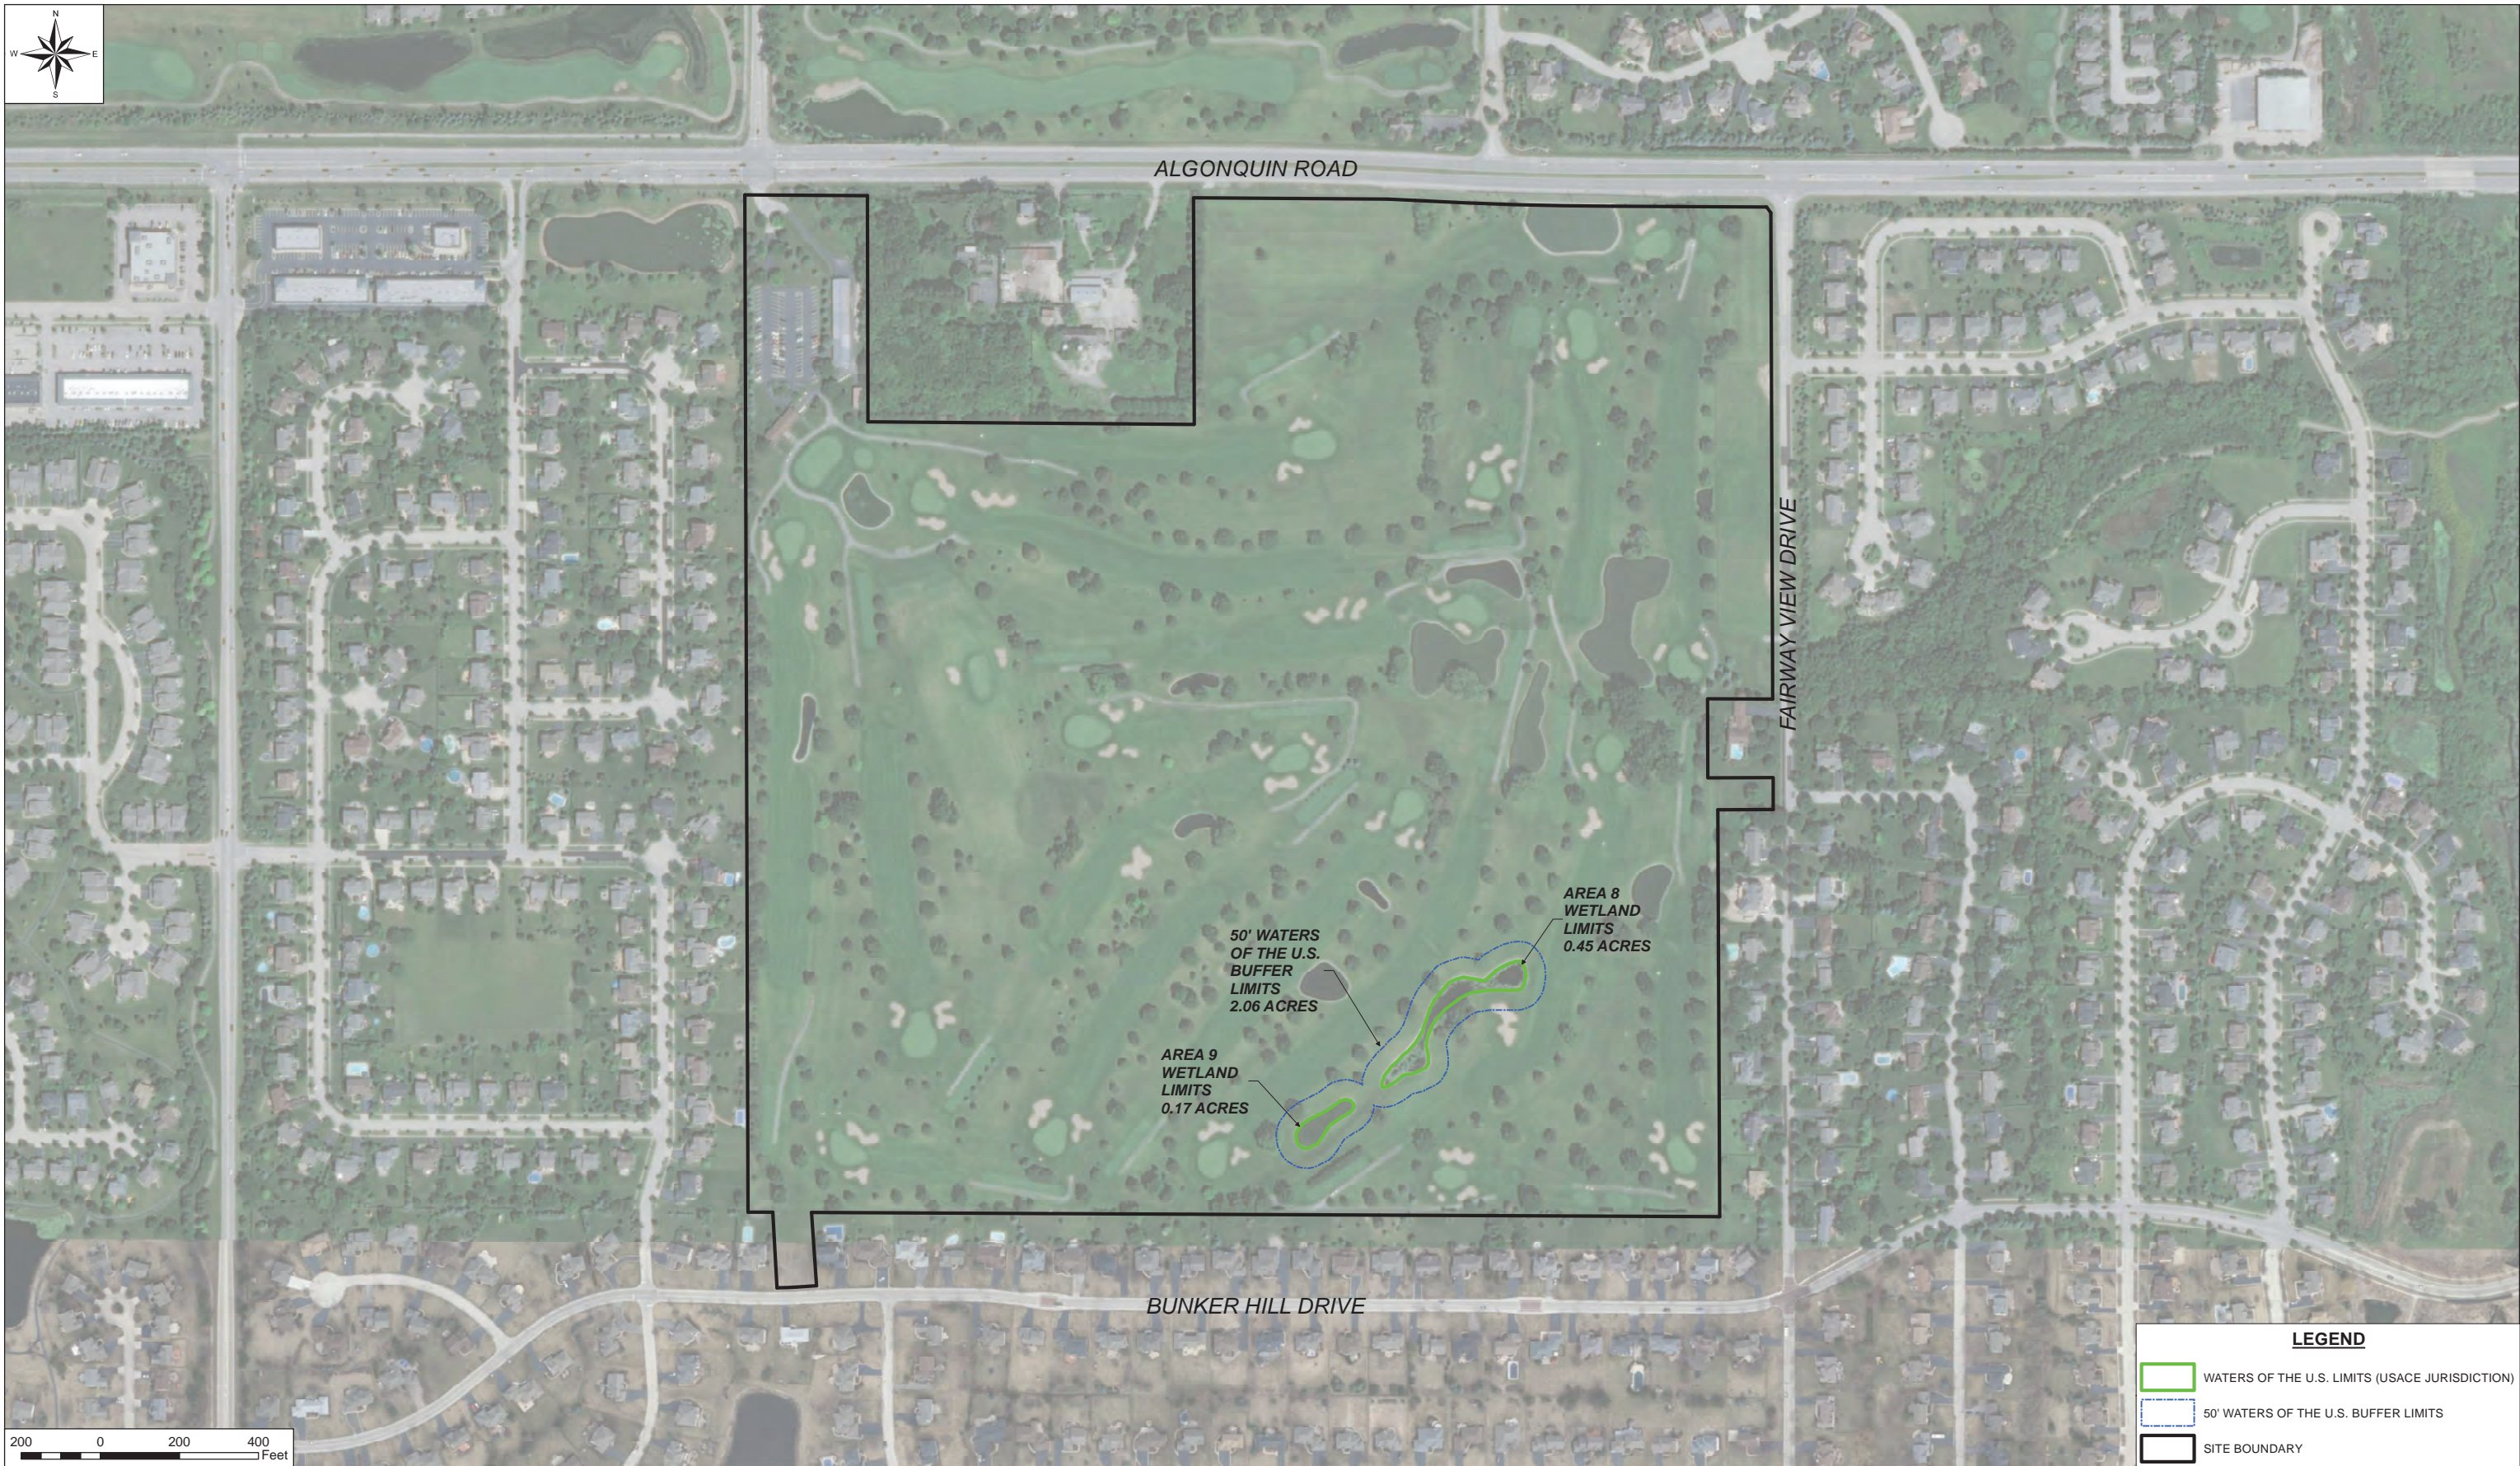
EXHIBIT
A

LEGEND	
	WATERS OF THE U.S. LIMITS (USACE JURISDICTION)
	50' WATERS OF THE U.S. BUFFER LIMITS
	SITE BOUNDARY

**EXISTING WATERS OF THE U.S.
 AND BUFFER CONDITIONS**

As shown on Exhibit A (Appendix 2), Areas 8 and 9 are the only areas that are regulated on the site. Areas 8 and 9 are Waters of the U.S. under the jurisdiction of the USACE. A permit has been applied for through the USACE Chicago District for the proposed improvements to Areas 8 and 9 and will be forwarded to the Village of Algonquin upon receipt.

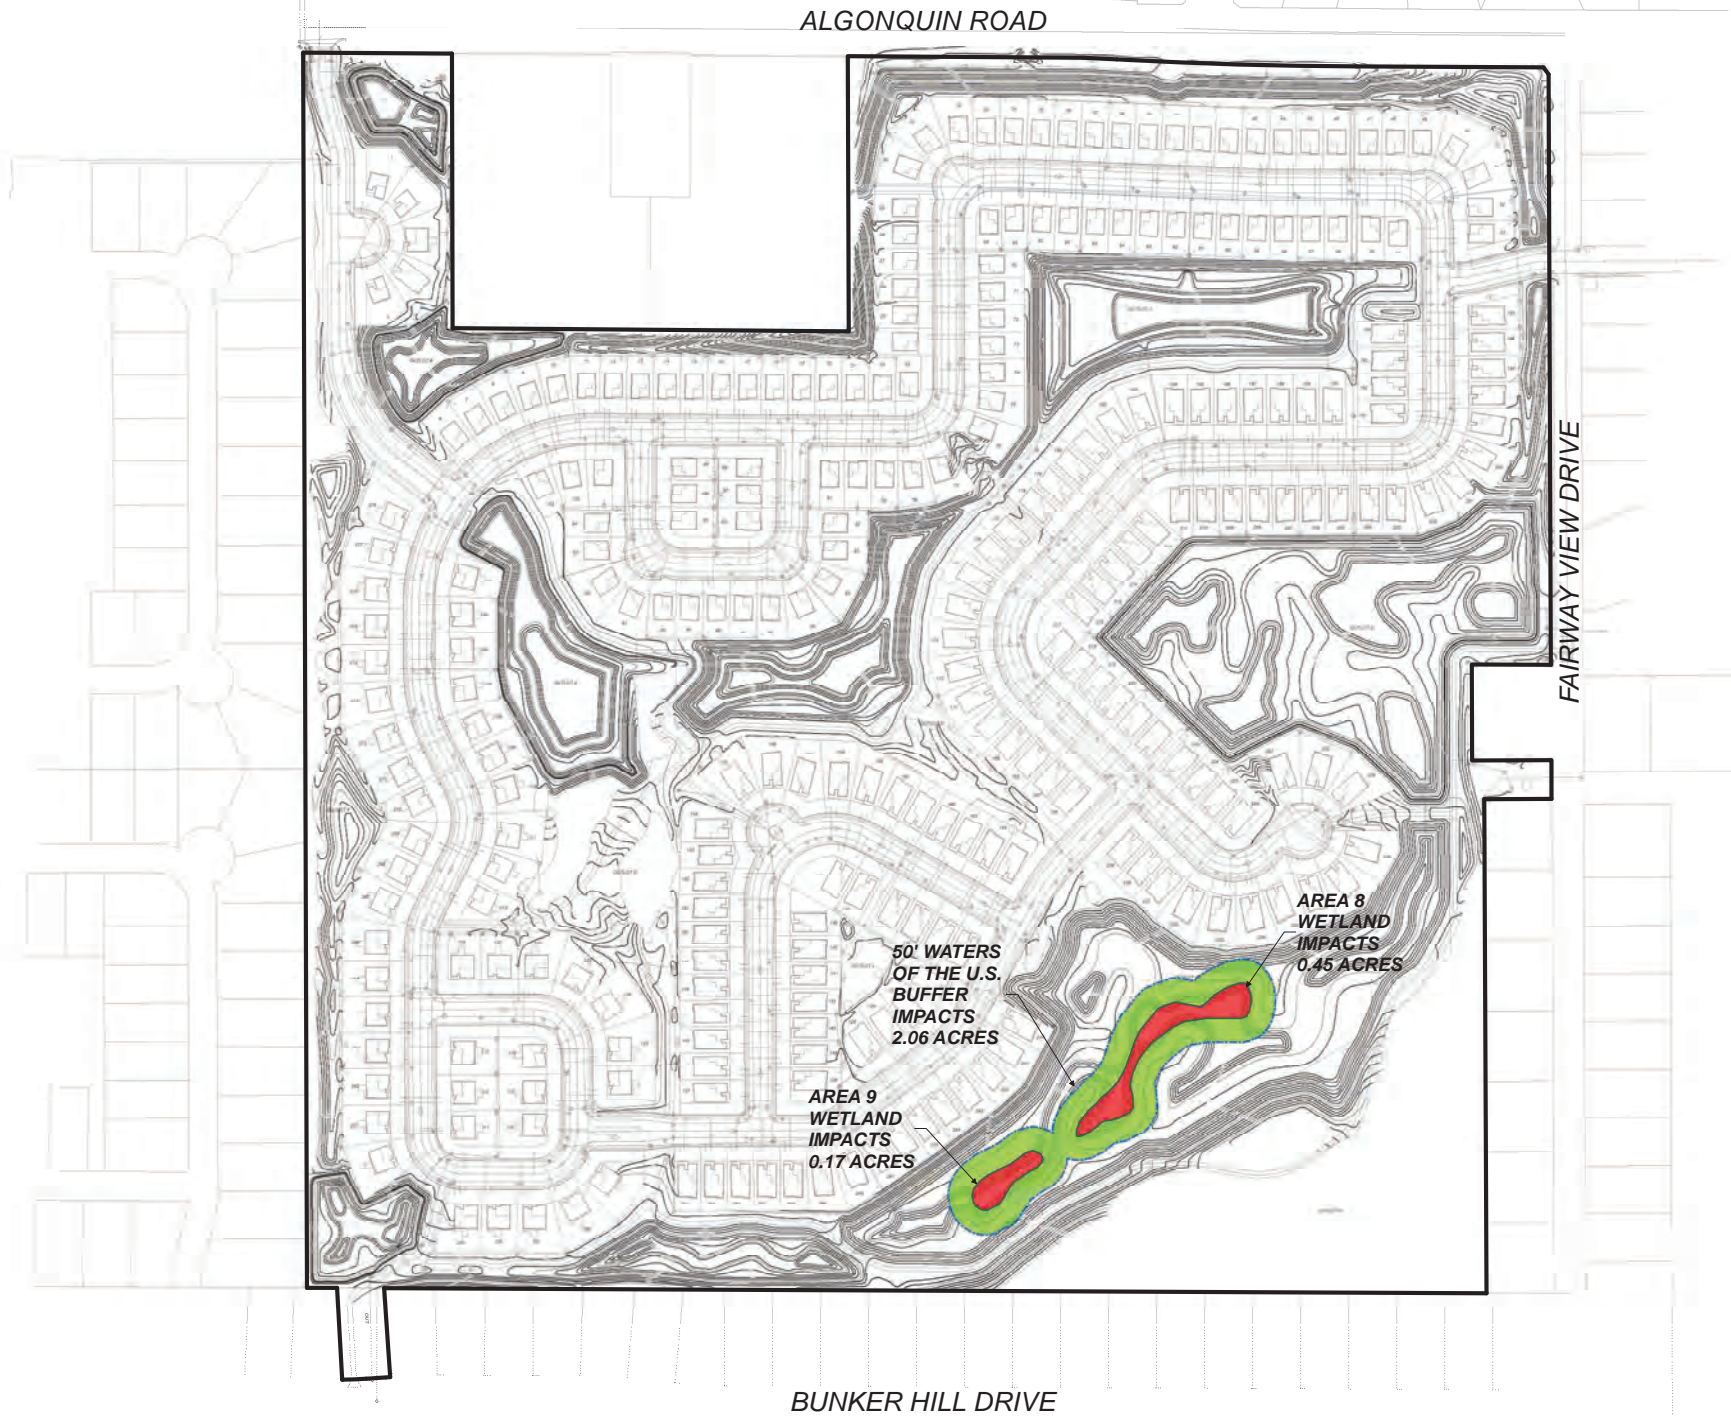
EXHIBIT
B

LEGEND	
	Waters of the U.S. Impacts (0.62 acres)
	Waters of the U.S. Buffer Impacts (2.06 acres)
	WATERS OF THE U.S. LIMITS
	50' WATERS OF THE U.S. BUFFER LIMITS
	SITE BOUNDARY

WATERS OF THE U.S. AND BUFFER IMPACTS

As shown on Exhibit B in Appendix 2 of this submittal, the proposed project will result in no impacts to isolated wetlands/Waters under the jurisdiction of the Village of Algonquin. The improvements proposed to Areas 8 and 9 are being permitted through the USACE Chicago District.

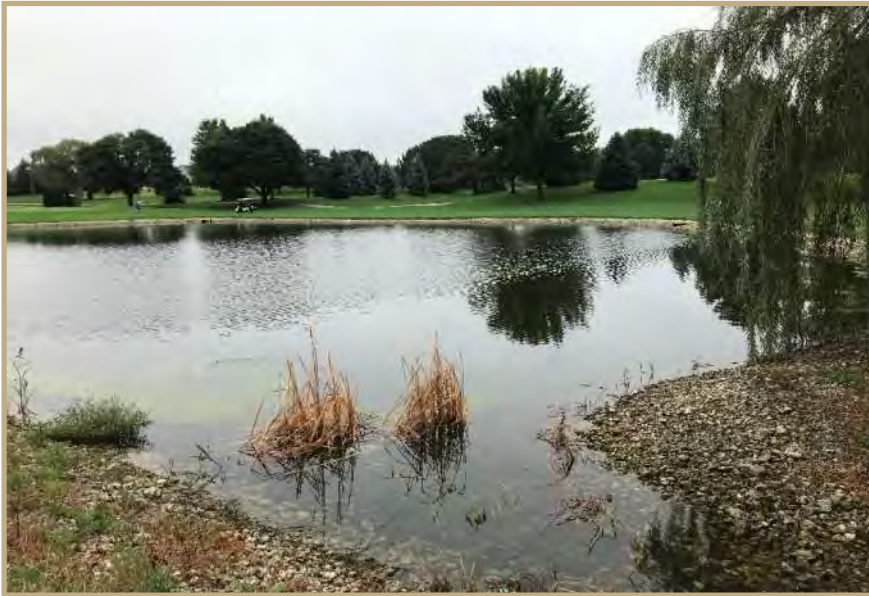
PHOTO 1

View of Area 1 facing southeast.

Conclusion: Data Point X01 fails to satisfy the vegetation and soils criterion and does not qualify as wetland. Area 1 is a water feature exempt from regulation.

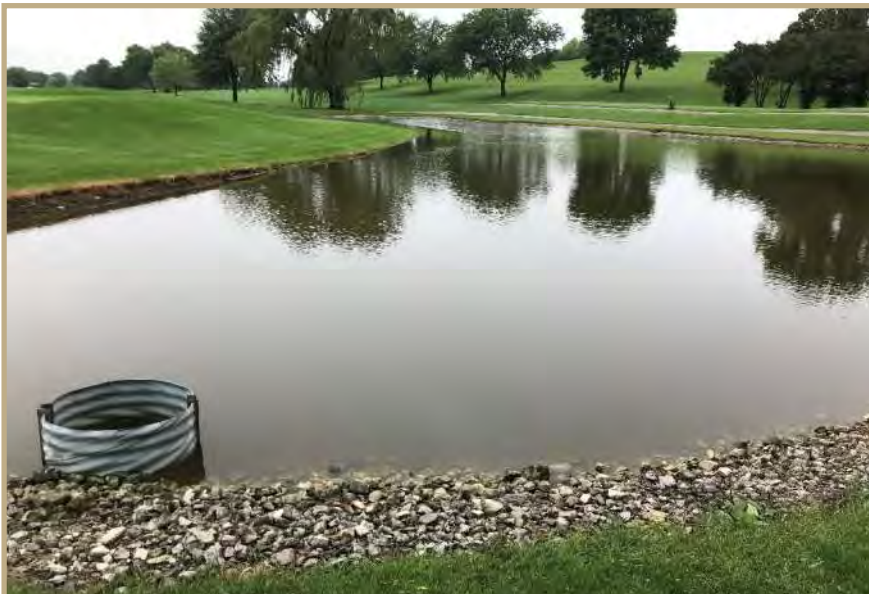
PHOTO 2

Conclusion: Data Point X02 fails to satisfy the vegetation and soils criterion and does not qualify as wetland. Area 2 is a water feature exempt from regulation.

View of Area 2 facing southwest.

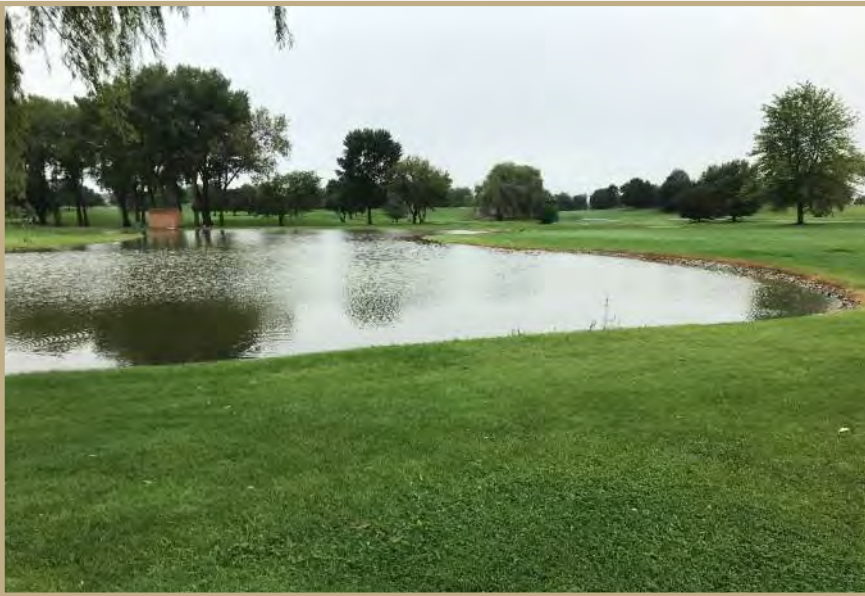
PHOTO 3

Conclusion: Data Point X03 fails to satisfy the vegetation and soils criterion and does not qualify as wetland. Area 3 is a water feature exempt from regulation.

View of Area 3 facing southwest.

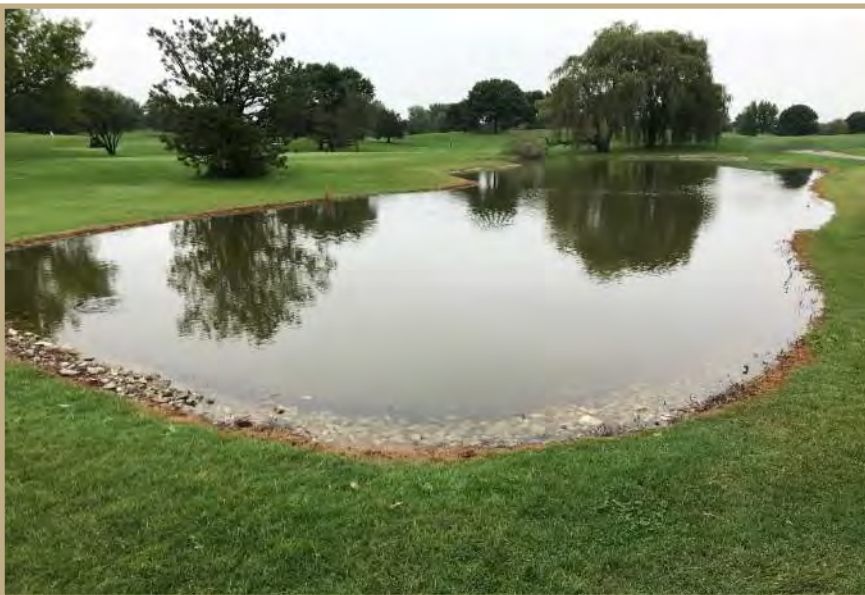
PHOTO 4

Conclusion: Data Point X06 fails to satisfy the vegetation and soils criterion and does not qualify as wetland. Area 4 is a water feature exempt from regulation.

View of Area 4 facing south.

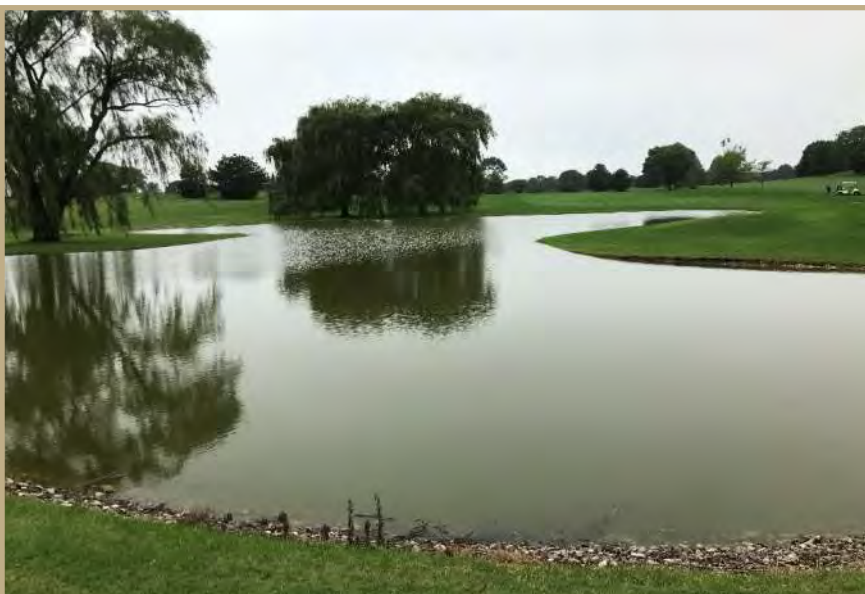
PHOTO 5

Conclusion: Data Point X05 fails to satisfy the vegetation and soils criterion and does not qualify as wetland. Area 5 is a water feature exempt from regulation.

View of Area 5 facing west.

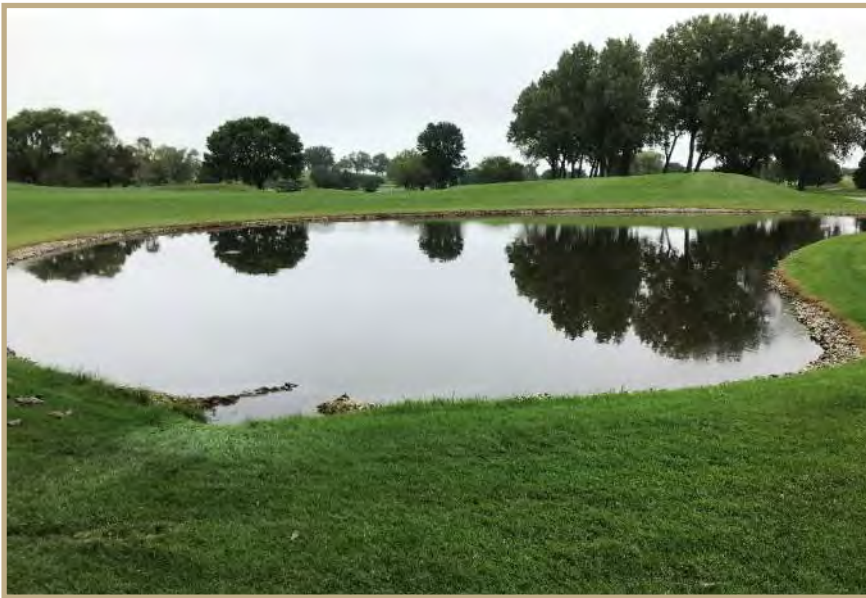
PHOTO 6

Conclusion: Data Point X04 fails to satisfy the vegetation and soils criterion and does not qualify as wetland. Area 6 is a water feature exempt from regulation.

View of Area 6 facing southwest.

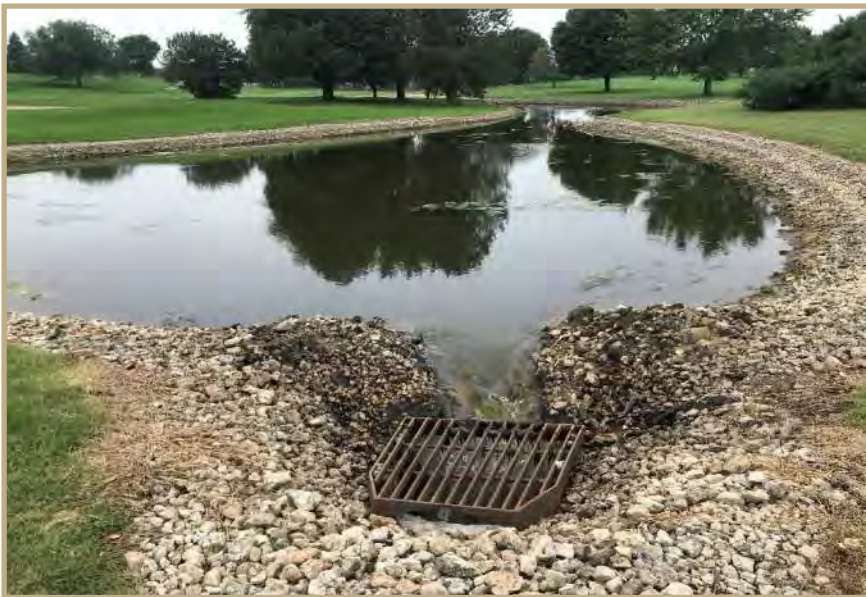
PHOTO 8

View of Area 8 facing southwest.

Conclusion: Data Point X08 fails to satisfy the vegetation and soils criterion and does not qualify as wetland. However, Area 8 is a Waters of the U.S., an unnamed tributary to Woods Creek.

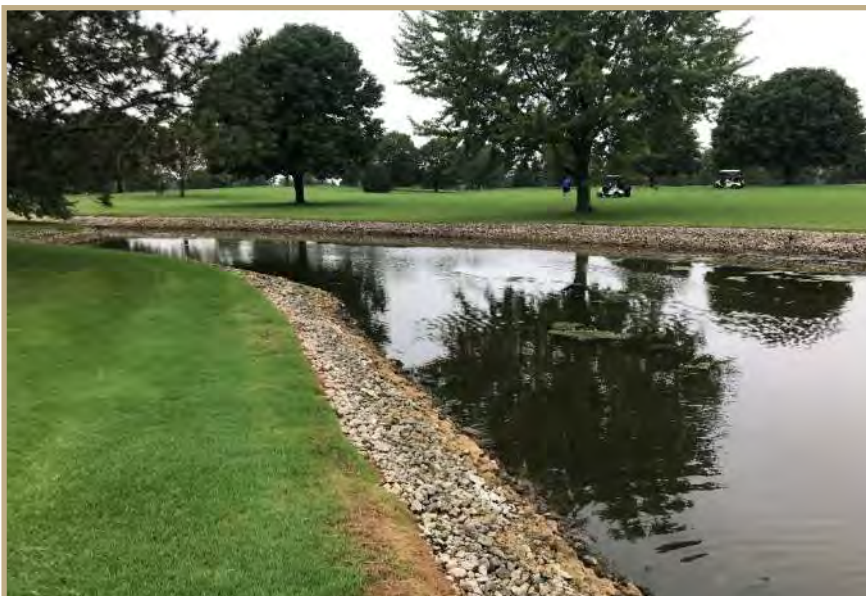
PHOTO 9

View of Area 9 facing south.

Conclusion: Data Point X09 fails to satisfy the vegetation and soils criterion and does not qualify as wetland. However, Area 9 is a Waters of the U.S., an unnamed tributary to Woods Creek.

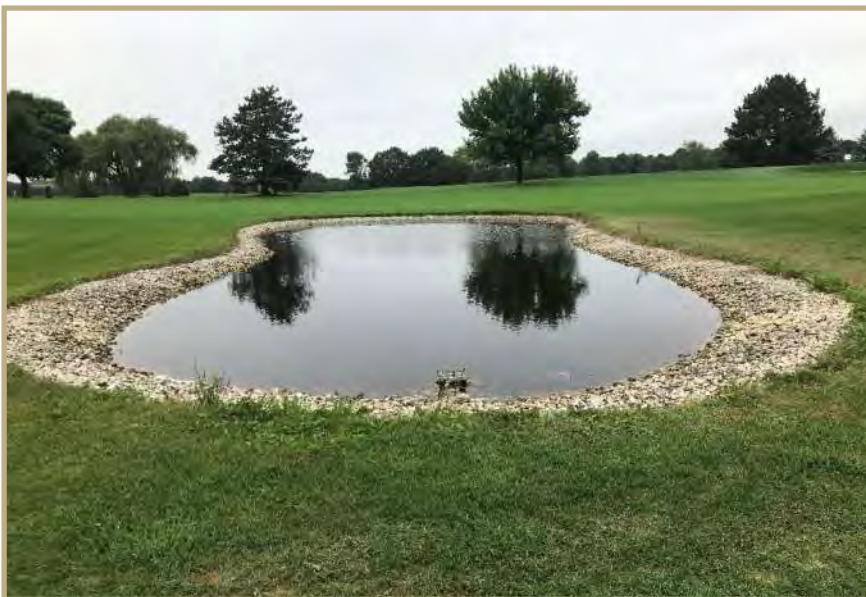
PHOTO 10

Conclusion: Data Point X10 fails to satisfy the vegetation and soils criterion and does not qualify as wetland. Area 10 is a water feature exempt from regulation.

View of Area 10 facing west.

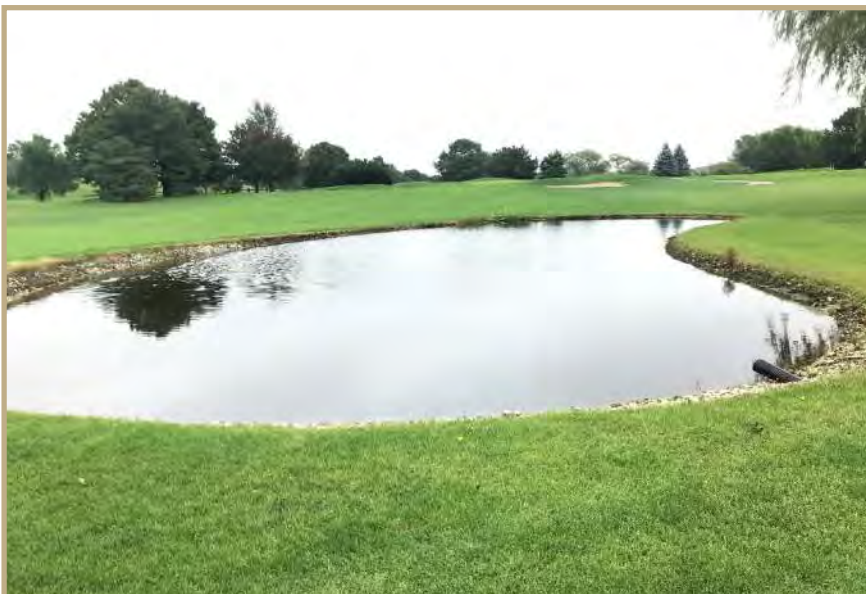
PHOTO 11

Conclusion: Data Point X11 fails to satisfy the vegetation and soils criterion and does not qualify as wetland. Area 11 is a water feature exempt from regulation.

View of Area 11 facing west.

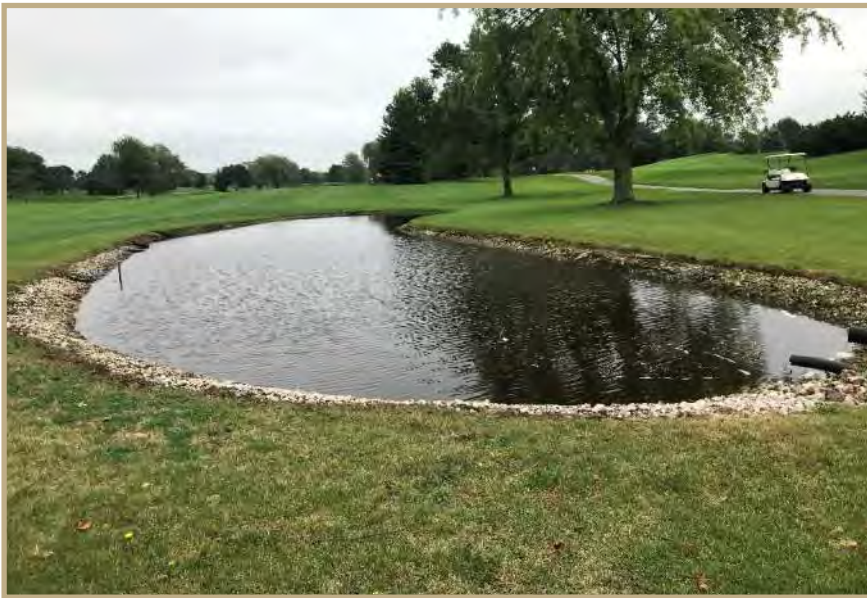
PHOTO 12

Conclusion: Data Point X12 fails to satisfy the vegetation and soils criterion and does not qualify as wetland. Area 12 is a water feature exempt from regulation.

View of Area 12 facing east.

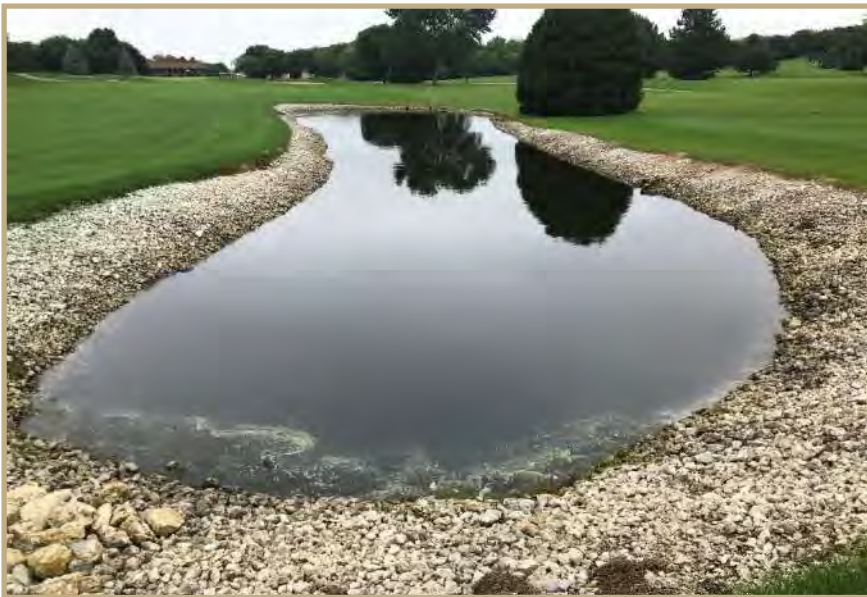
PHOTO 13

Conclusion: Data Point X13 fails to satisfy the vegetation and soils criterion and does not qualify as wetland. Area 13 is a water feature exempt from regulation.

View of Area 13 facing east.

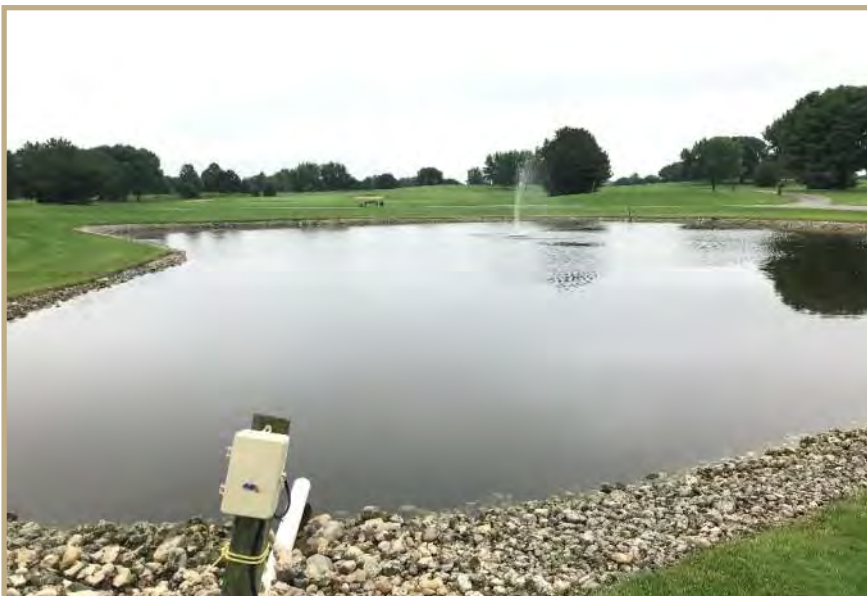
PHOTO 14

Conclusion: Data Point X14 fails to satisfy the vegetation and soils criterion and does not qualify as wetland. Area 14 is a water feature exempt from regulation.

View of Area 14 facing south.

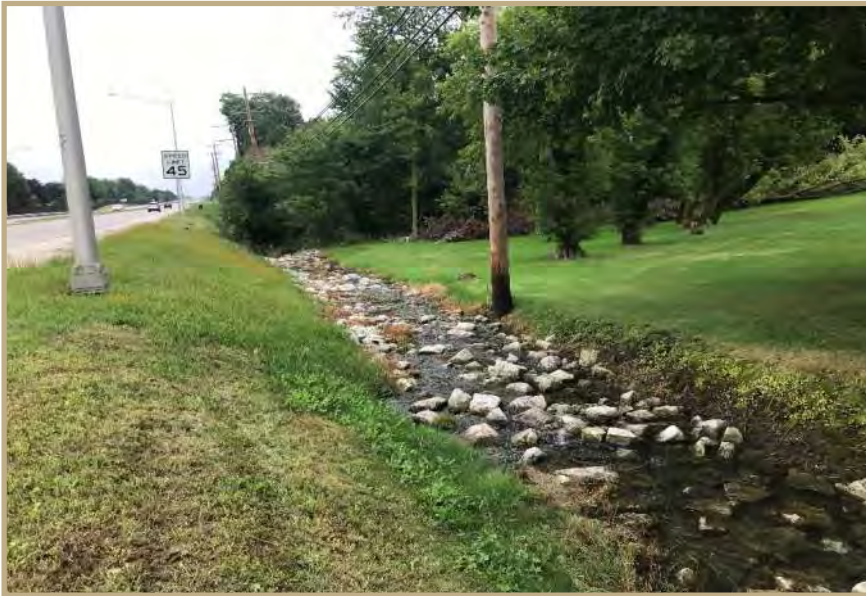
PHOTO 16

View of Area 16, the roadside ditch, facing southeast.

Conclusion: Data Point X16 fails to satisfy the vegetation and soils criterion and does not qualify as wetland. This area is a roadside ditch exempt from regulation.

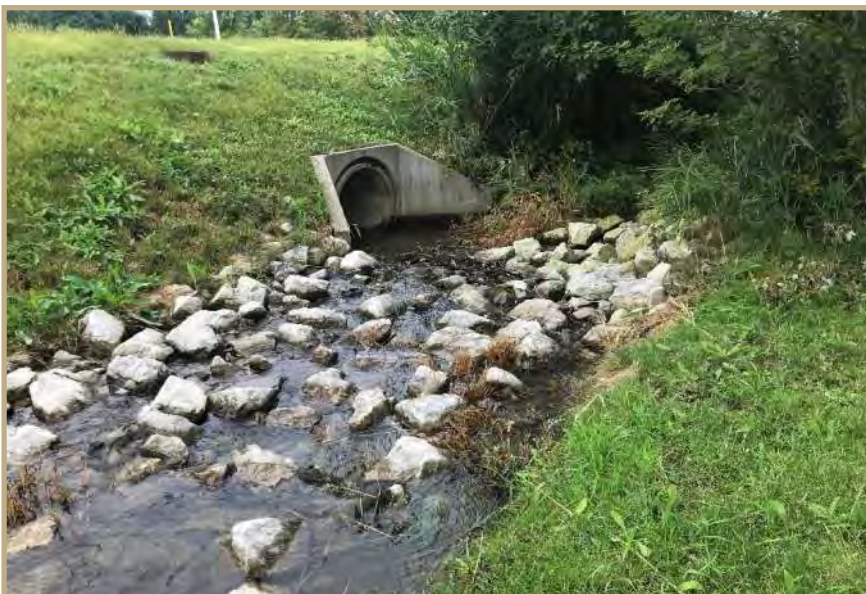
PHOTO 18

View of the culvert under Algonquin Road, facing northeast.

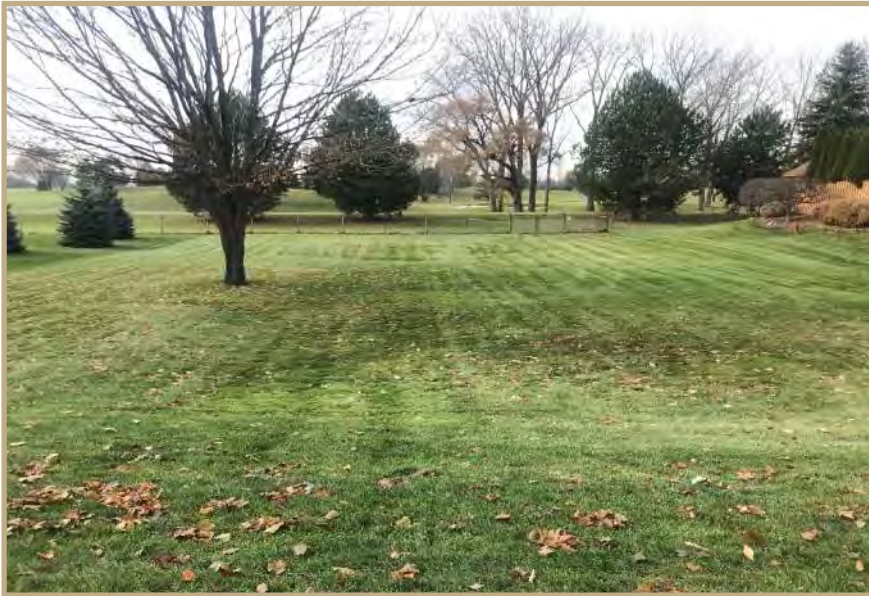
PHOTO 19

View of Area 17 near Data Point X17 facing west.

Soils: The soil profile at Data Point X17 consisted of 0-15 inches of mixed fill comprised of very dark grayish brown (10YR 3/2) and brown (10YR 4/3) silty clay loam. Hydric soil indicators were not observed, so the soils criterion is not satisfied.

Hydrology: Neither primary nor secondary wetland hydrology indicators were observed at Data Point X17, so the hydrology criterion is not satisfied.

Conclusion: Data Point X17 fails to satisfy the soil and hydrology criteria and does not qualify as wetland.

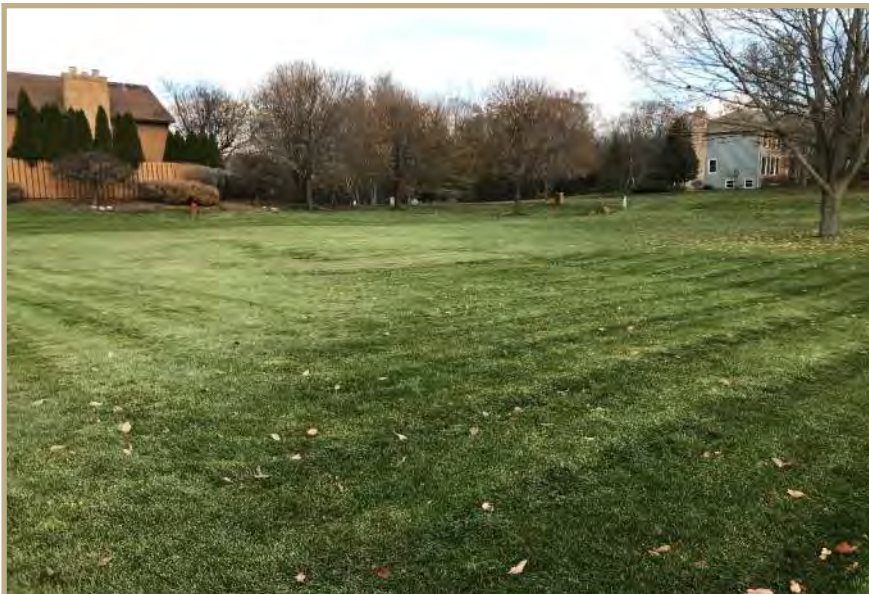
PHOTO 20

View of Area 17 near Data Point X17 facing east.

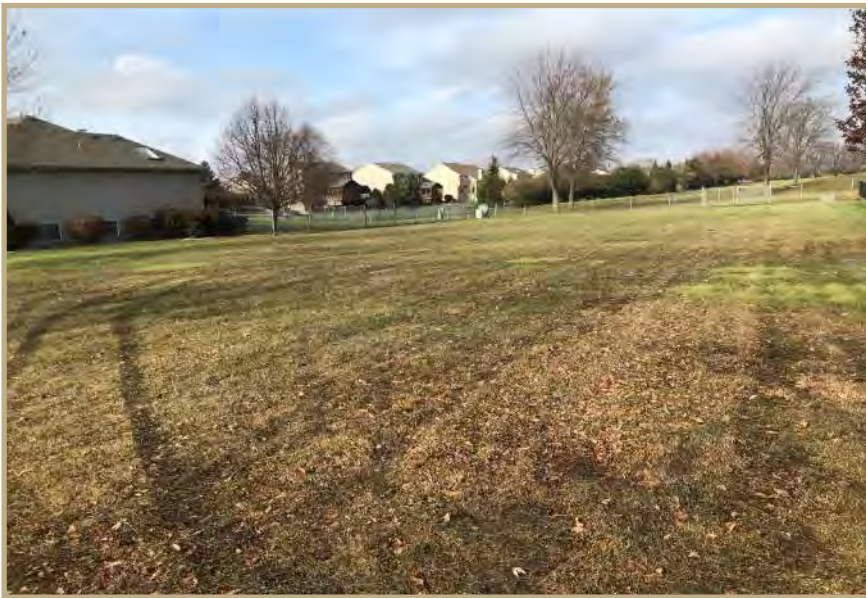
PHOTO 22

View of Area 18 facing northwest.

Soils: The soil profile at Data Point X18 consisted of 0-15 inches of mixed fill comprised of black (10YR 2/1), very dark grayish brown (10YR 3/2) and brown (10YR 4/3) silty clay loam. Hydric soil indicators were not observed, so the soils criterion is not satisfied.

Hydrology: Neither primary nor secondary wetland hydrology indicators were observed at Data Point X18, so the hydrology criterion is not satisfied.

Conclusion: Data Point X18 fails to satisfy the soil and hydrology criteria and does not qualify as wetland.

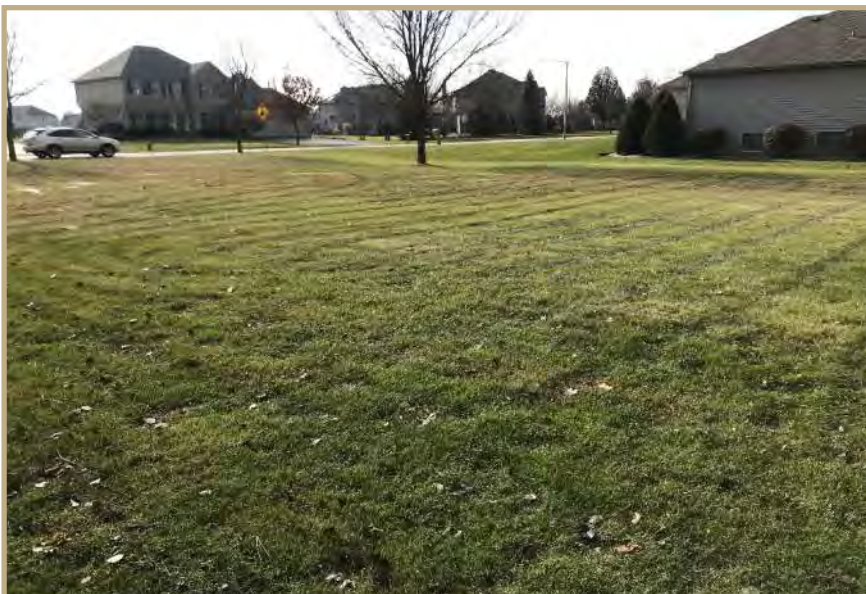
PHOTO 23

View of Area 18 facing southeast.

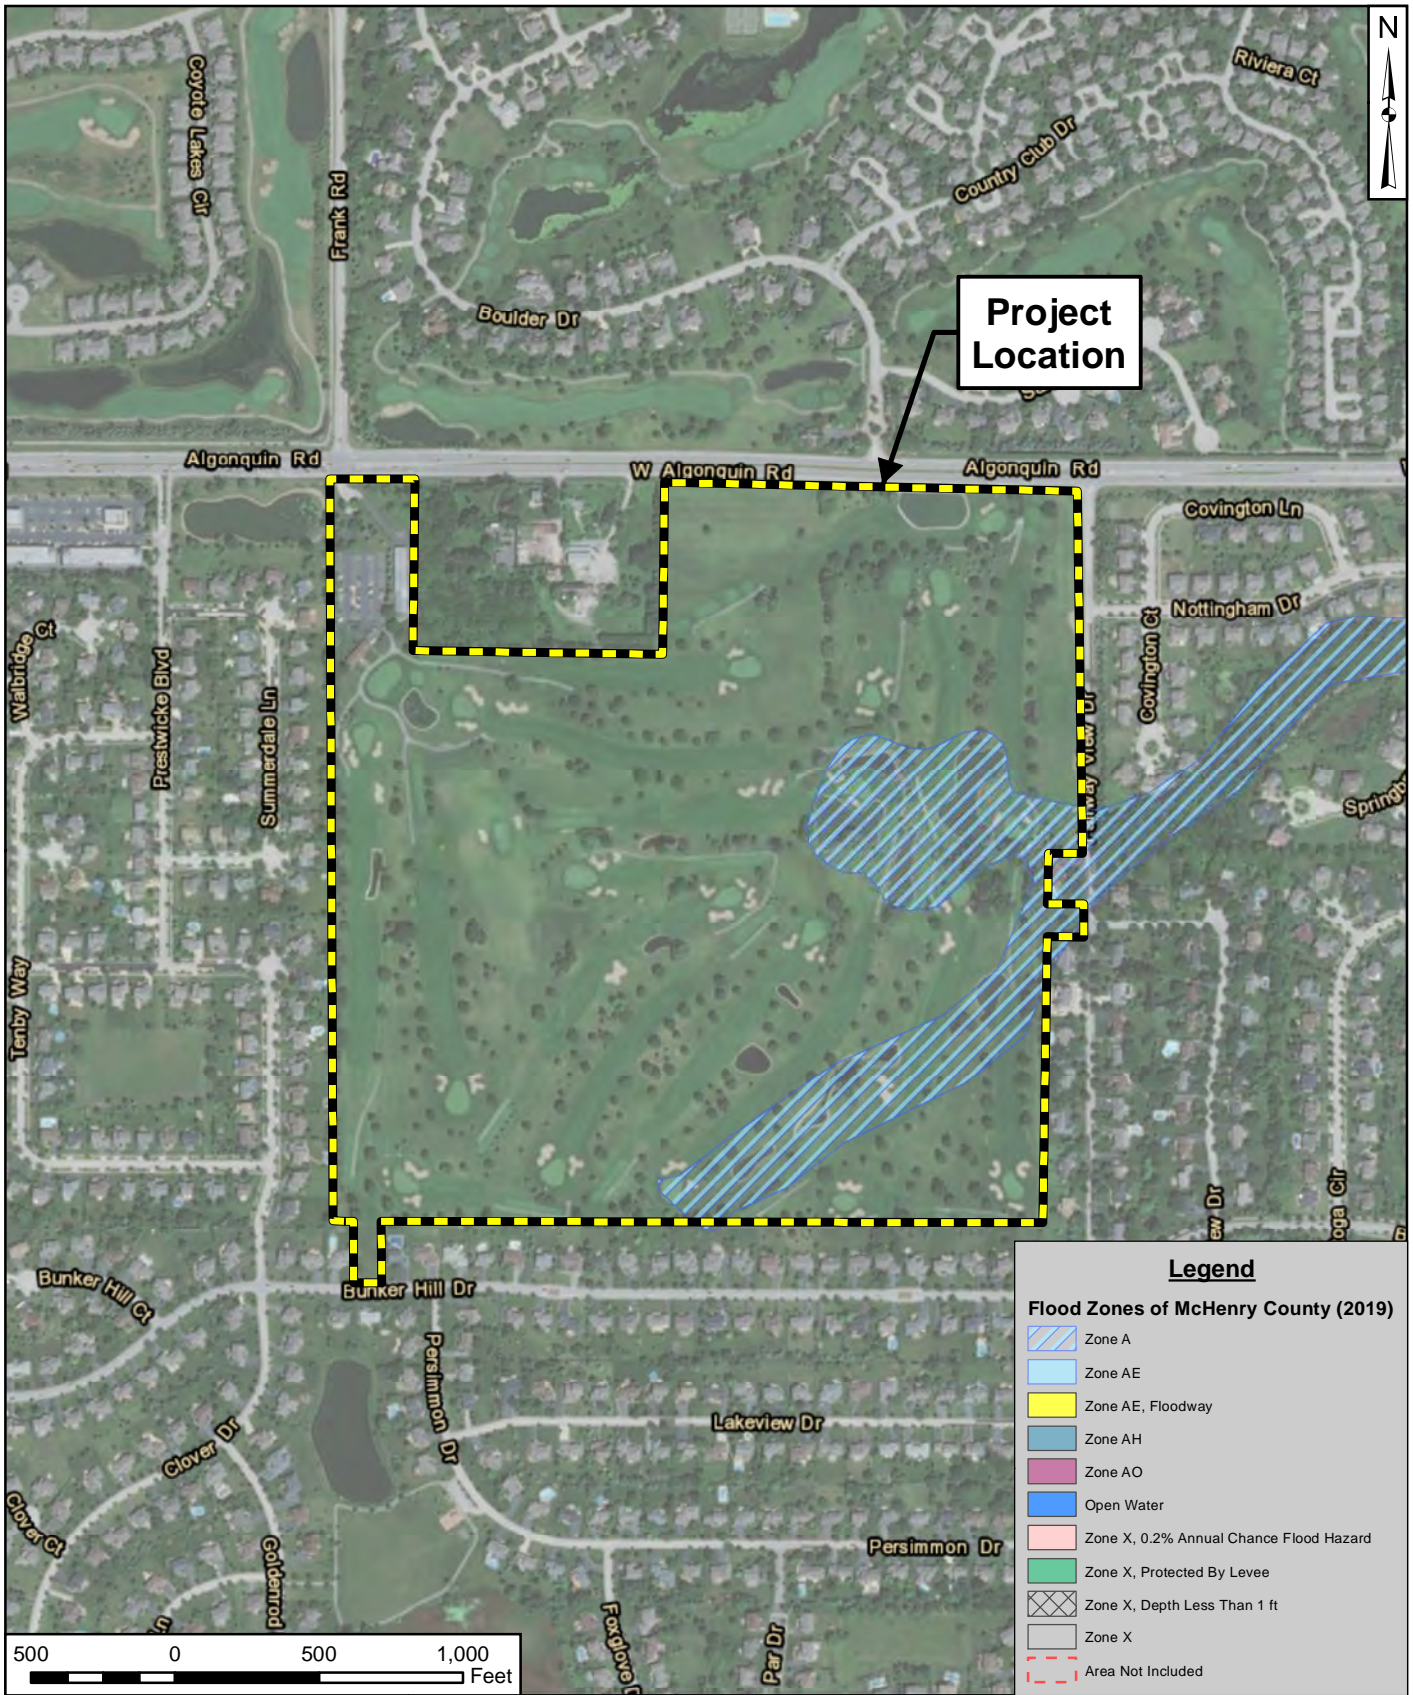
The Flood Zones of McHenry County, Illinois (2019) Map (Figure 7) shows flood zone A in the southeast portion of the subject property.

<p>7325 Janes Avenue Woodridge, IL 60517 630.724.9200 phone www.v3co.com</p>	PROJECT NO.:	CLIENT:	FLOOD ZONES OF MCHENRY COUNTY, ILLINOIS (2019) MAP	
	19381	Pulte Home Corporation 1900 E. Golf Road, Suite 300 Schaumburg, Illinois 60173		
	CREATED BY:	BASE LAYER:	SITE:	FIGURE:
	AMM	NAIP Aerial Imagery (2017)	Terrace Hill Algonquin, Illinois	7
Visio, Vertere, Virtute... "The Vision To Transform with Excellence"	DATE:	SCALE:		
	11/20/2019	See Scale Bar
